CHURCH OF THE HOLY SEPULCHRE JERUSALEM

STRUCTURAL SURVEY
FINAL REPORT

BY
WILLIAM HARVEY

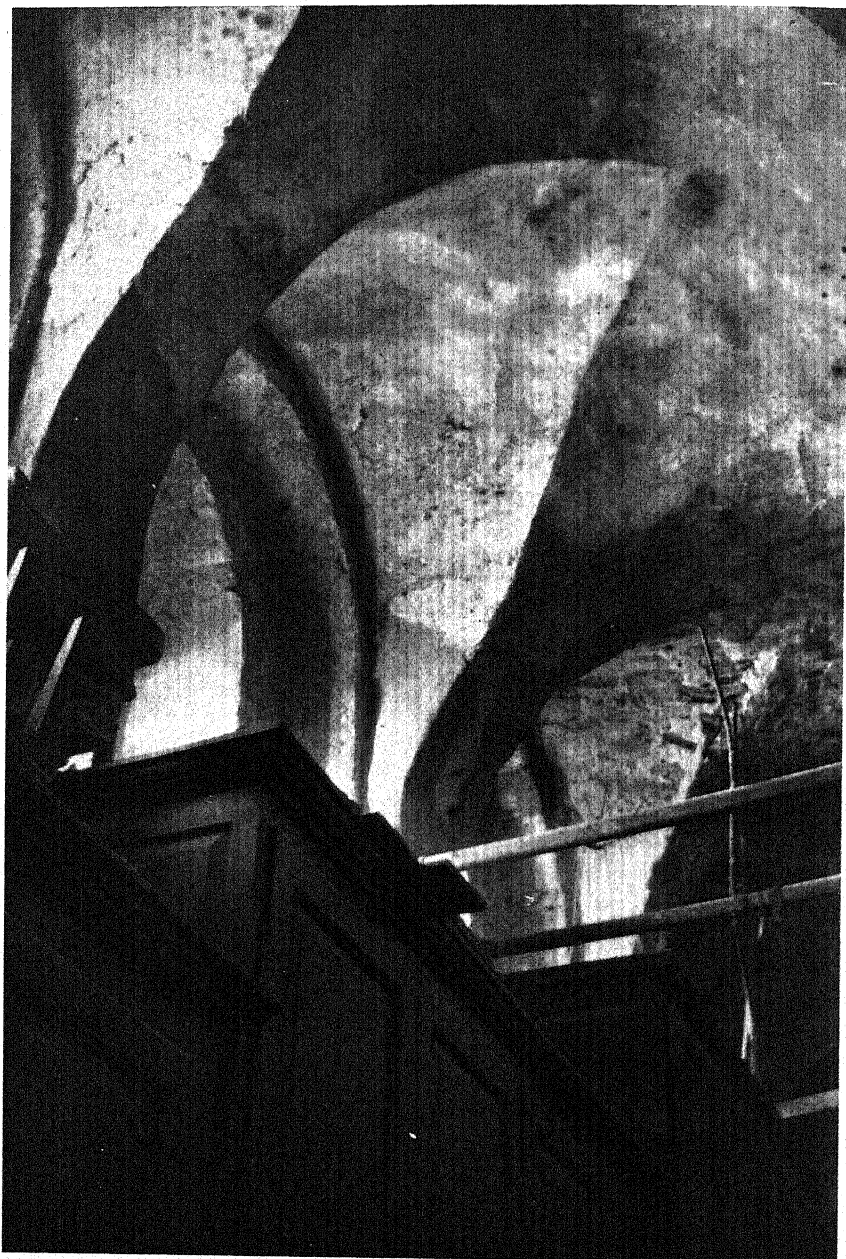
During plastering which took place eighteen months ago, it was found that the vault of the upper gallery was not in contact with the outer wall in many places (see Fig. 10); the very large cracks then visible are now hidden by the new plaster, but within the last few months the plasterwork has again shown cracks in the same positions as the hidden defects, thus indicating that movement is now continuing. The carved stone capitals of the attached half-columns supporting this vault are badly cracked owing to the pressure and torsion to which they are subjected.

FIG. 10. VAULT OF NORTH TRANSEPT UPPER GALLERY—
BEFORE RE-PLASTERING

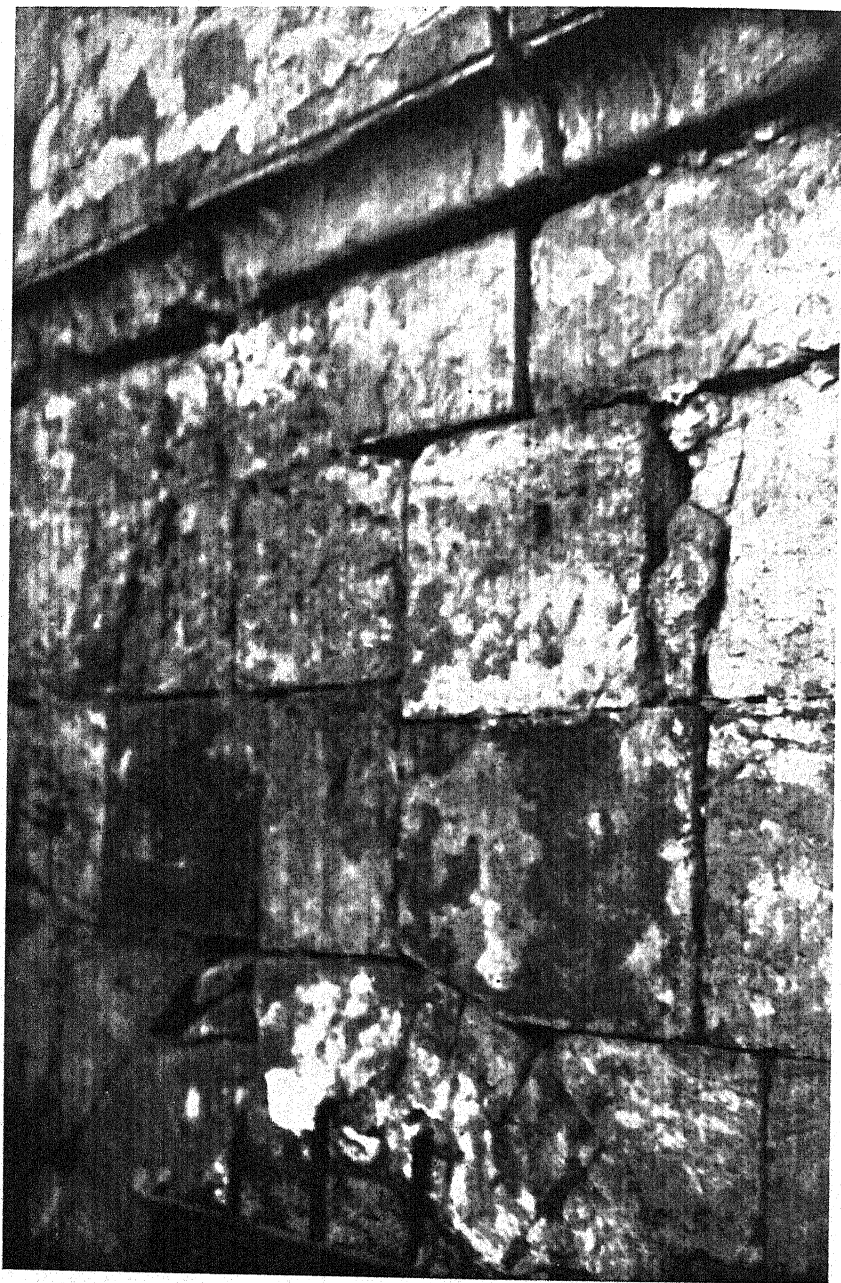
The high vault itself (see Fig. 11) has also been plastered, but some two years ago a large stone fell from one of the main ribs, and the upper walls, where accessible from outside, are in an extremely poor condition (see Figs 12, 13, 14), many joints being completely denuded of mortar, and much of the masonry cracked and suffering from erosion, and to some extent from the effects of the fire of 1808.

FIG. 14. NORTH TRANSEPT HIGH VAULT. E. WALL

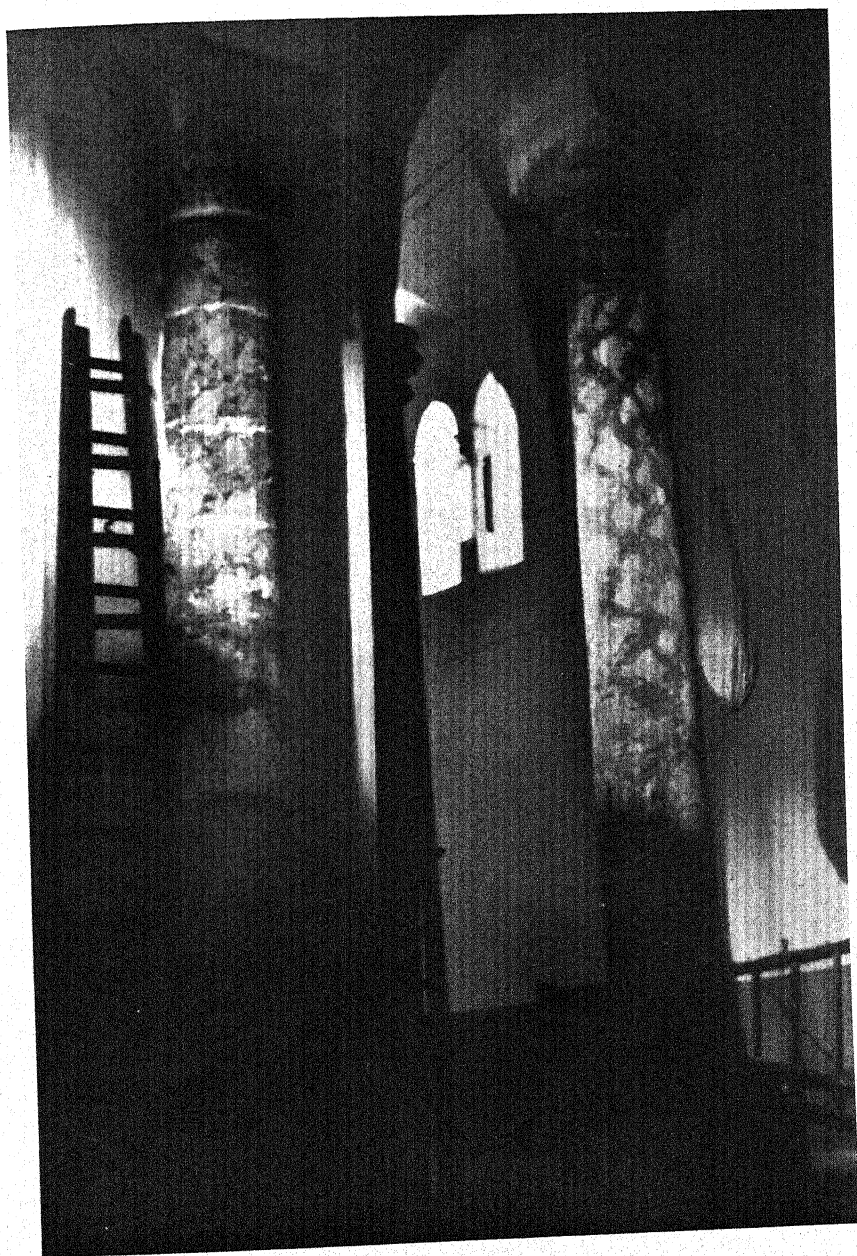
The marble columns of the Byzantine arcade (see Fig. 15) are seriously cracked as a result of the thrusts, and of the great weight resting upon them. The cracks appear to be recent, and loose splinters of the marble can be detached.

FIG. 15. E. COLUMN OF BYZANTINE ARCADE

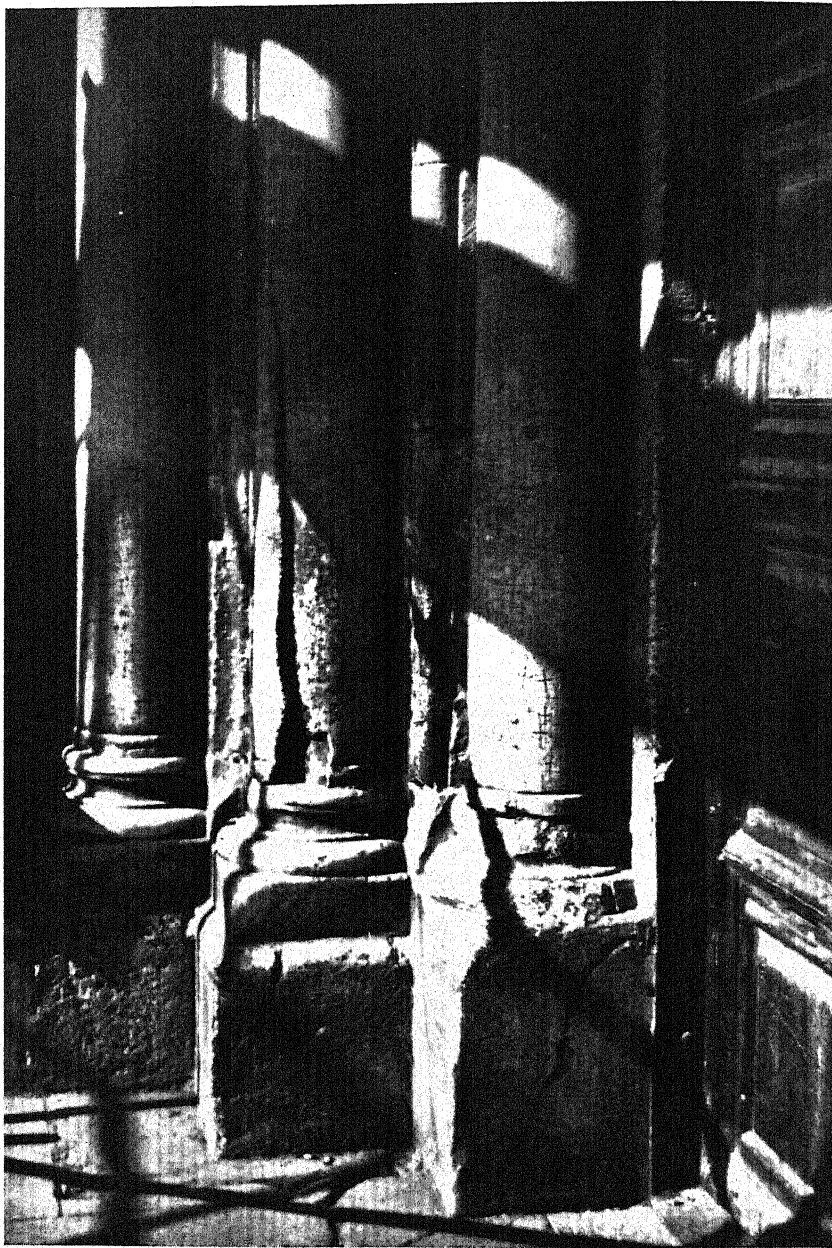
The lower colonnettes and their bases are almost all cracked, the oblique direction of the cracks showing the asymmetrical loading of the arches above (see Fig. 24). The condition of most of the carved work is extremely good (see Figs. 25, 26, 27, 28, 29) with the exception of the inner orders of the upper arches, which suffered most from the fire (see Figs. 30, 31, 32).

FIG. 24. BASES TO W. OF MAIN DOOR

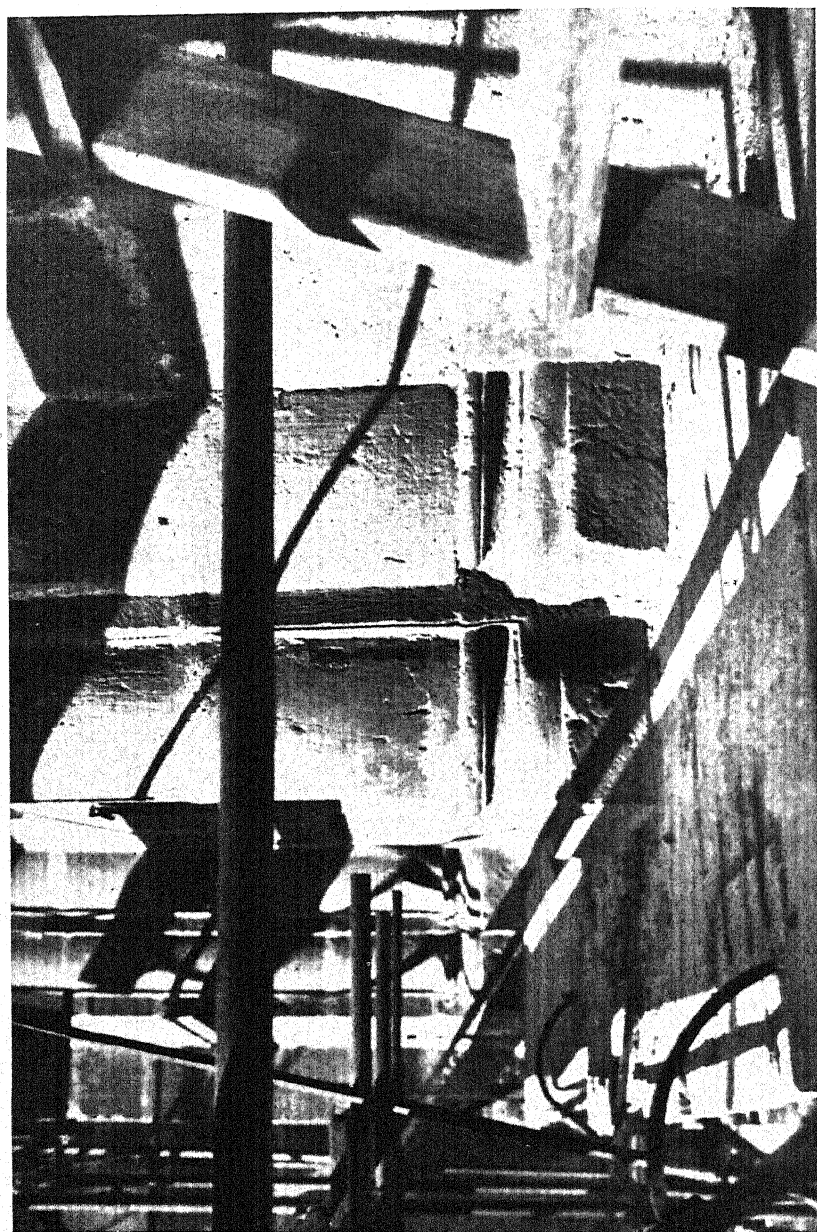
Serious cracks occur both from the outside of the wall (see Fig. 36) and in the attached pier within (see Fig. 37); while others between the vault and the wall have been covered by plaster (see Fig. 38) (see also Additional Notes, pp. 13 and 15).

FIG. 36. CRACKED BASES OF PIERS OF UPPER ARCADE

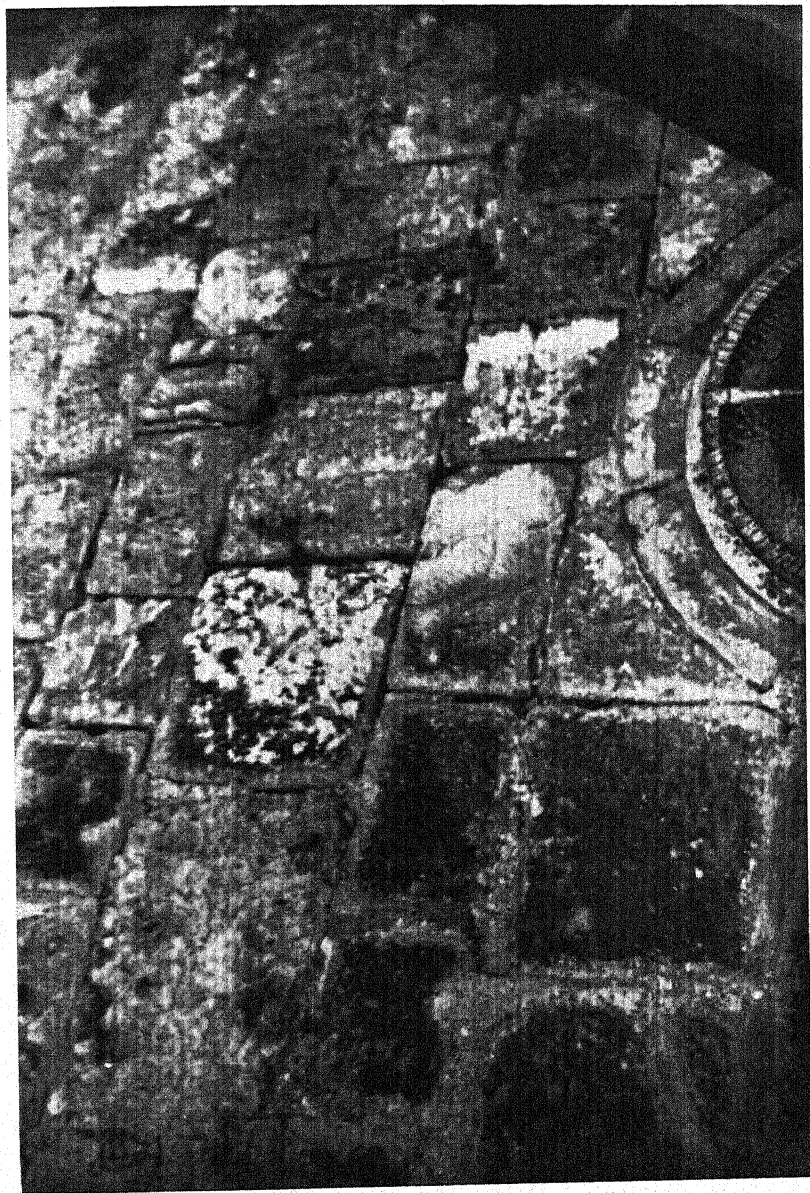
FIG. 36a. SOUTH TRANSEPT HIGH VAULT E. WALL TO SHOW FRACTURES
IN MASONRY AND JOINTS

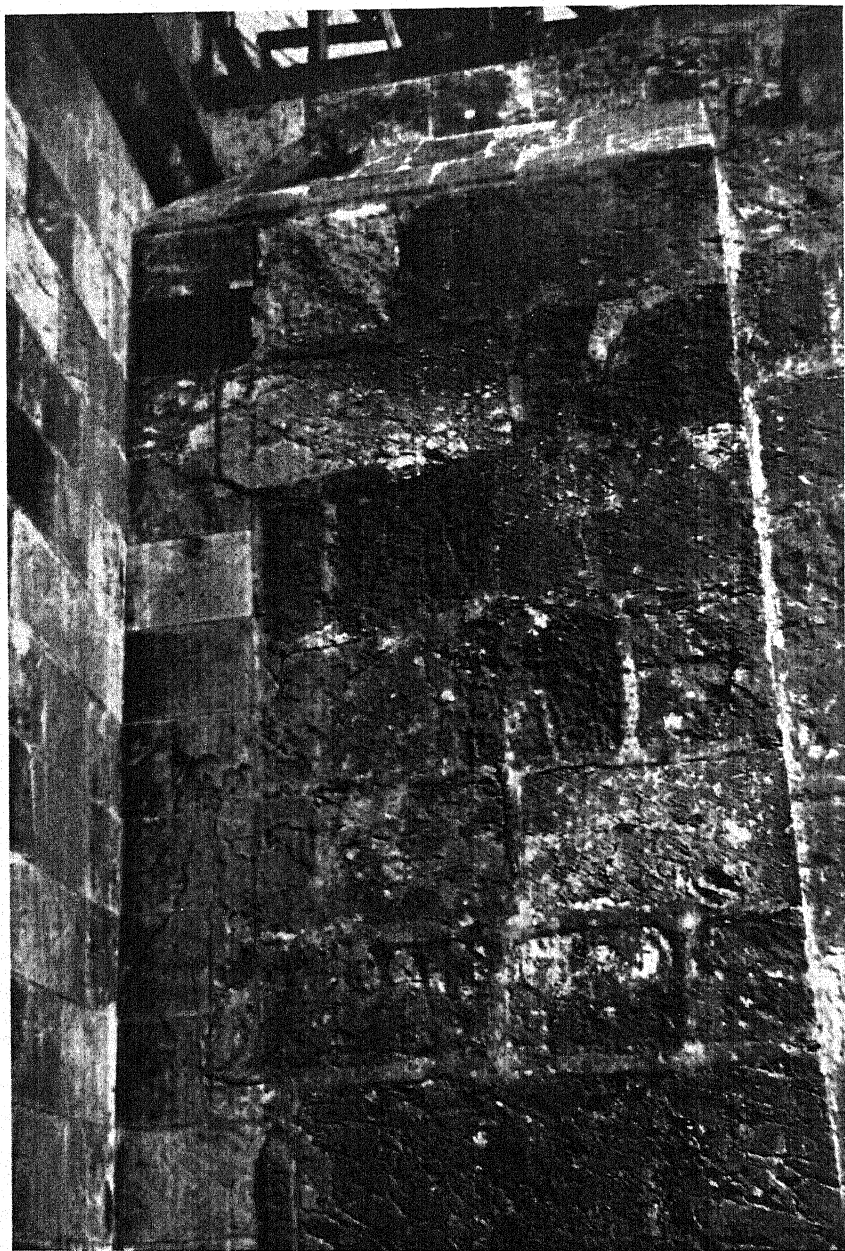
FIG. 36b. SOUTH TRANSEPT HIGH VAULT W. WALL
TO SHOW CRACK

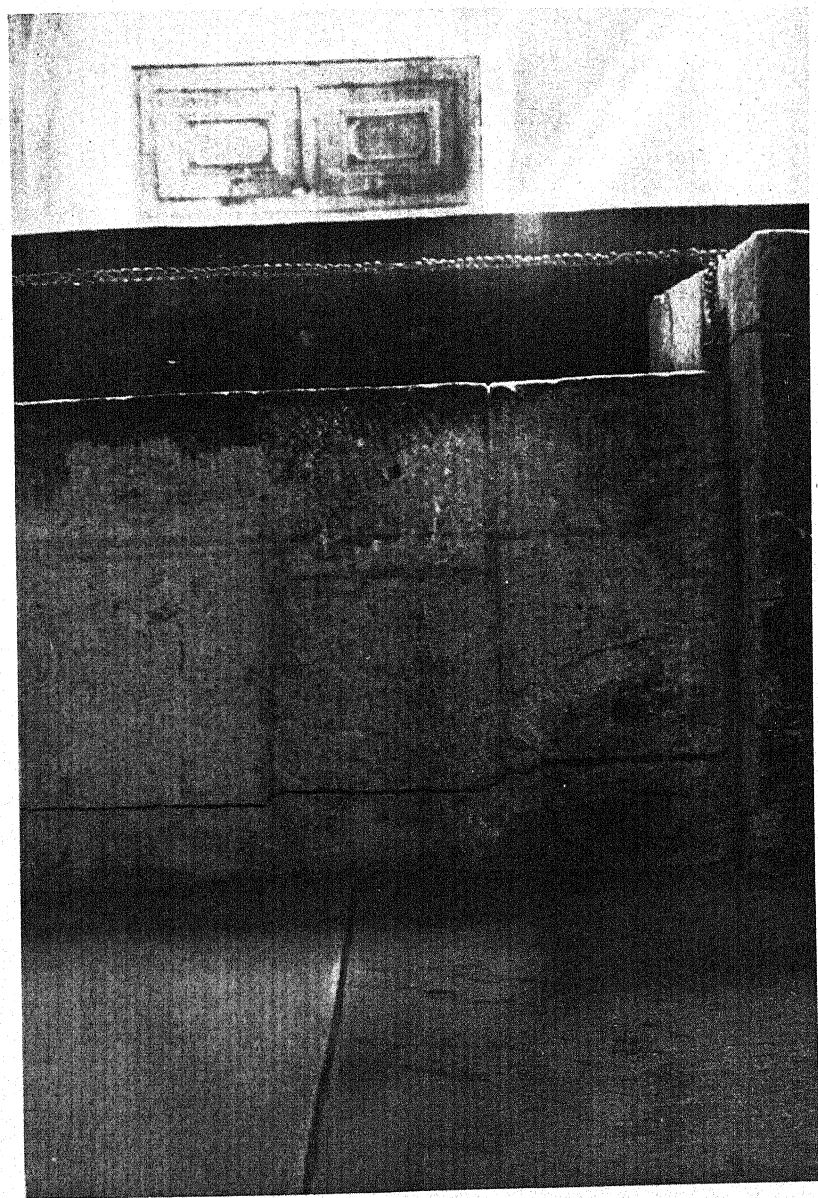
FIG. 37. FRACTURE IN ATTACHED PIER BETWEEN MAIN DOORS

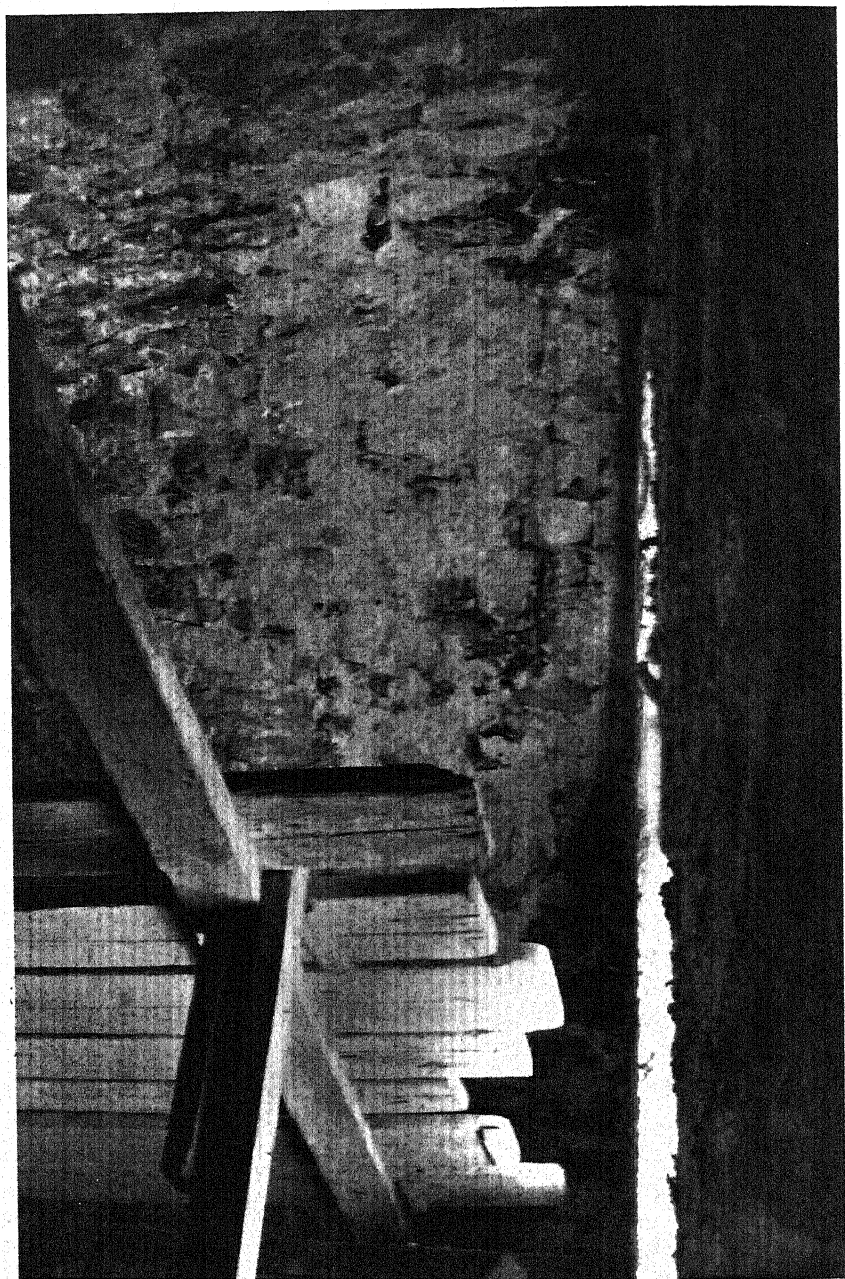
FIG. 38. CRACKED VAULT OF ARMENIAN GALLERY
BEFORE RE-PLASTERING

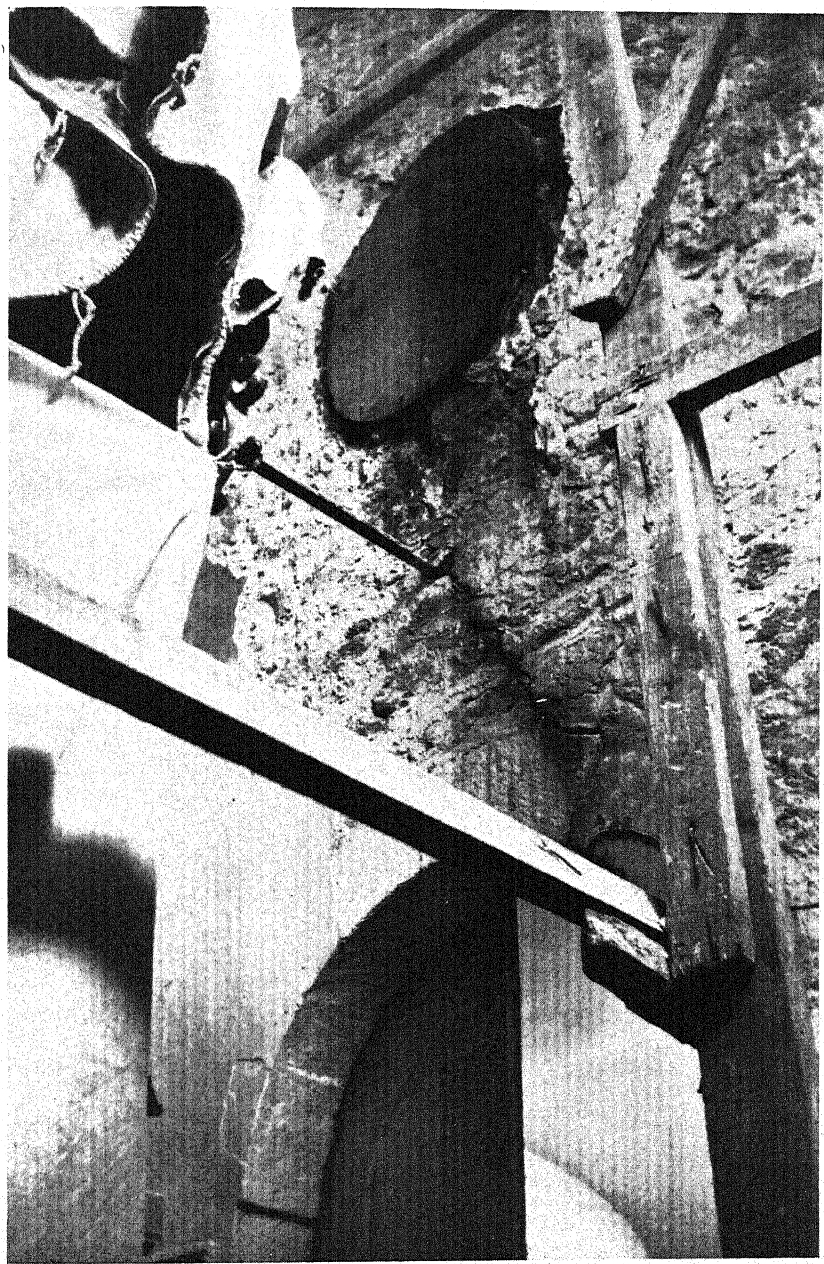
FIG. 38a. CRACK IN TRANSVERSE WALL OF ARMENIAN GALLERY
BEFORE RE-PLASTERING

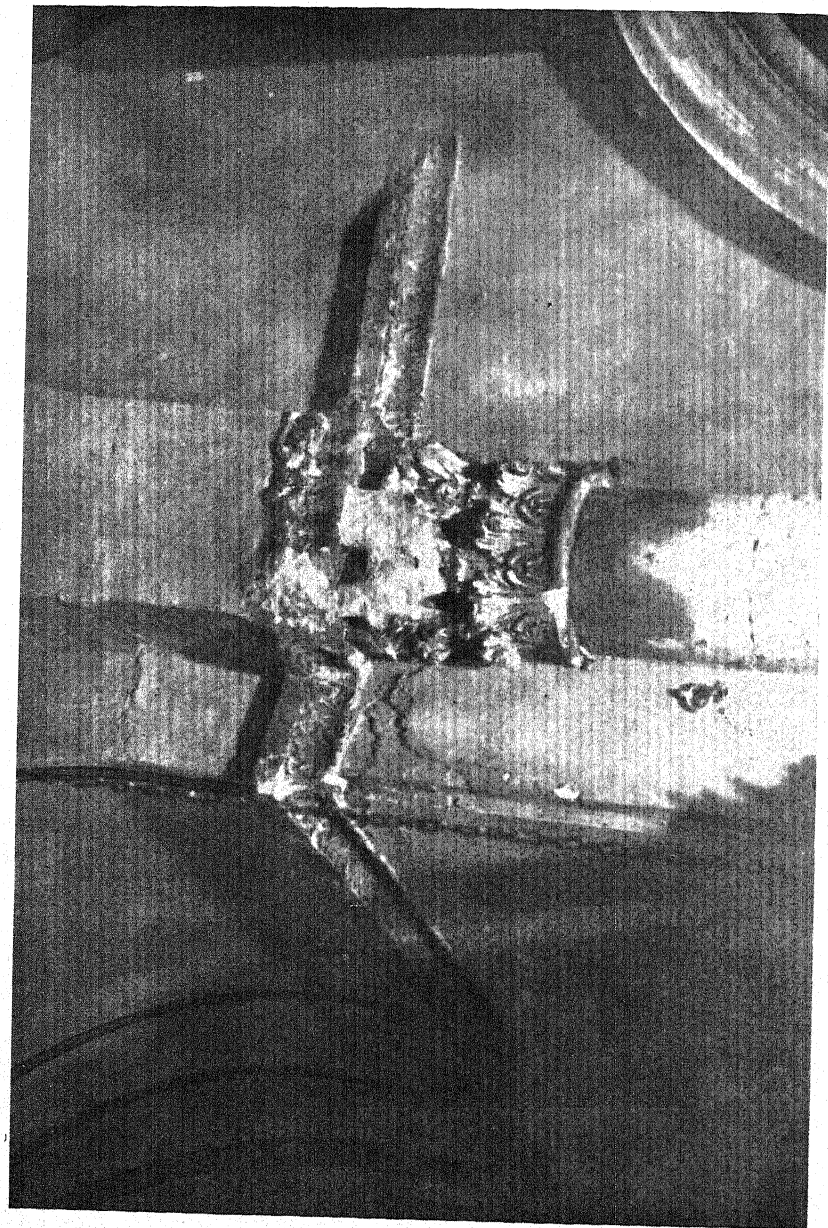
FIG. 43. CAPITAL DAMAGED RECENTLY. AMBULATORY

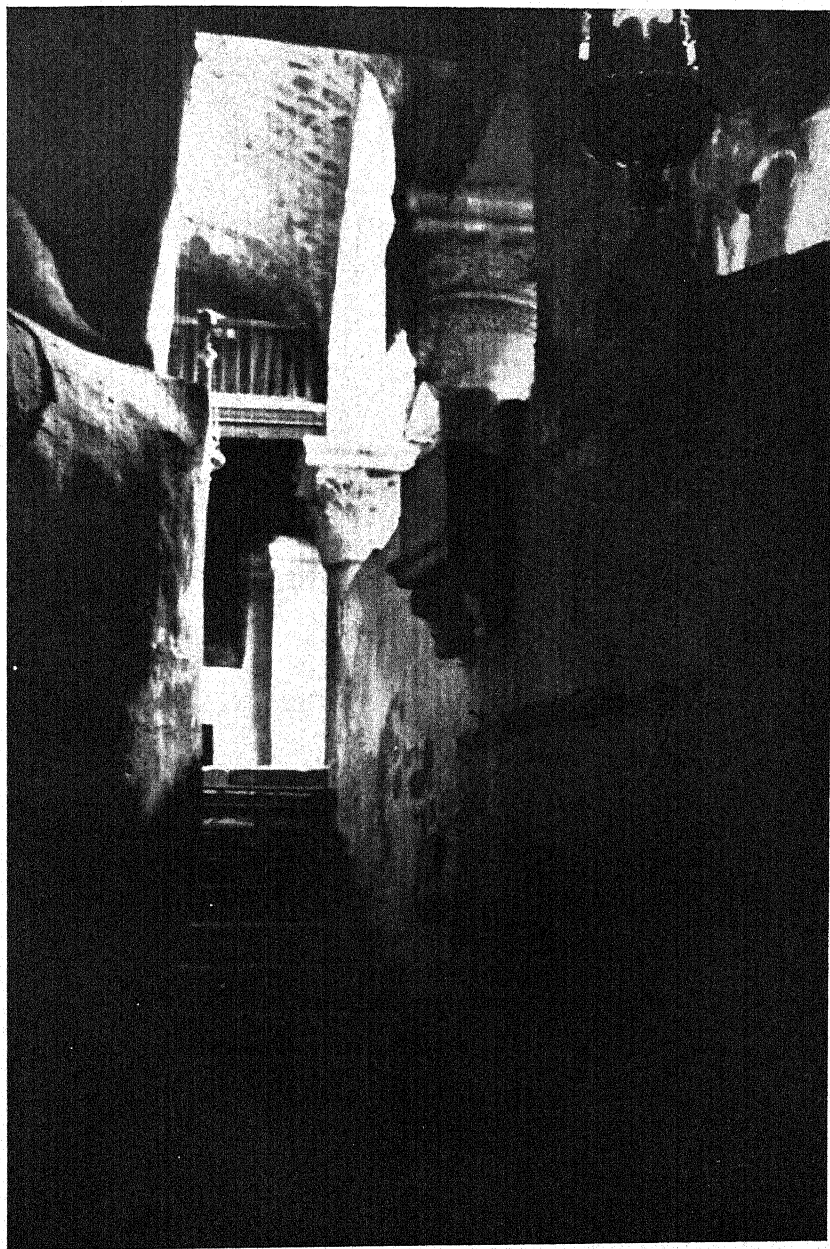
decay of structural consequence. The dome (see Fig. 46) leaks and requires water-proofing outside, as the rough-cast stucco has become badly cracked (see Fig. 47). The floor is in a bad state, also the flight of steps leading to the Grotto of the Invention (see Fig. 48); these are at present covered with iron gratings.

FIG. 48. STAIR TO GROTTO OF THE INVENTION

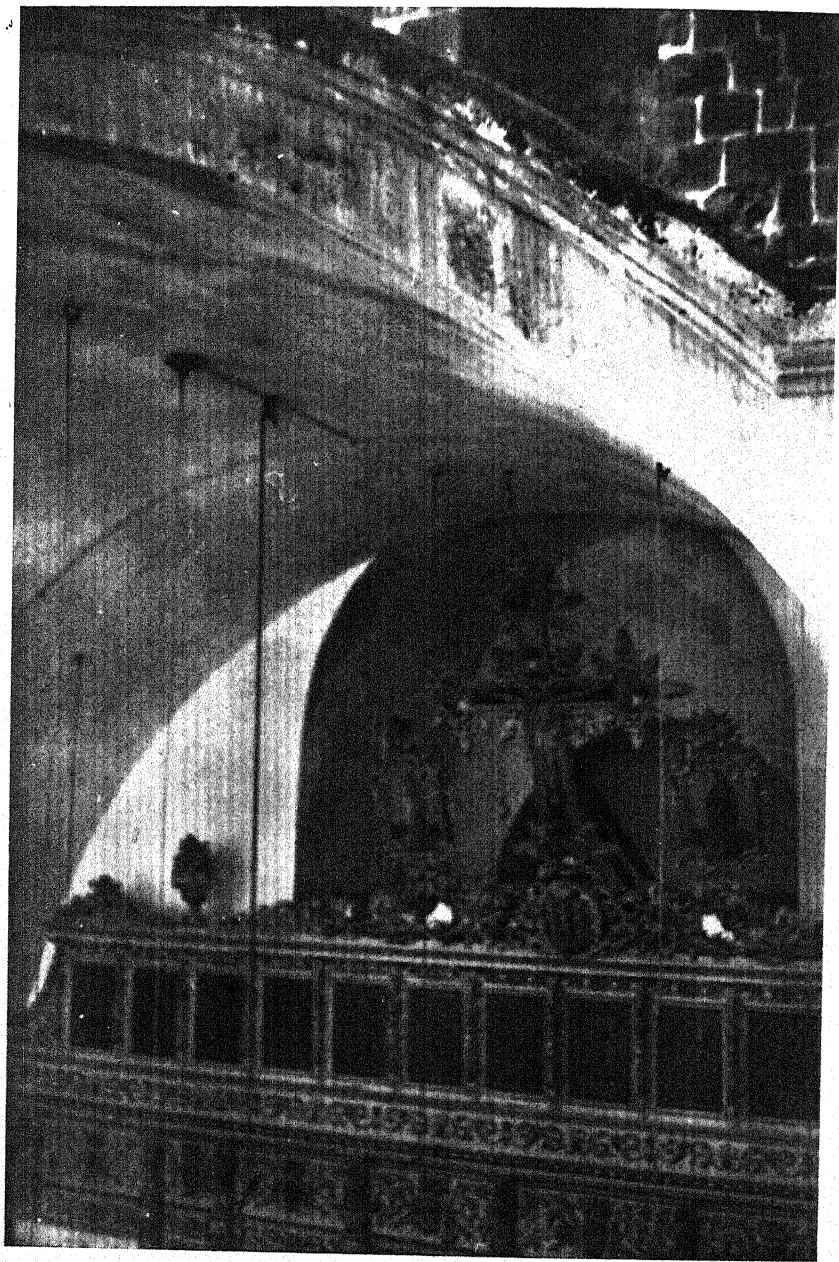
The Baptistery (see Figs. I, 32-II, 19), now partly open to the sky and in part vaulted over at a low level (see Fig. 59), shows little sign of decay in itself, but the thrust communicated to it by the Tower has succeeded in forcing its South wall outwards against the thrust of the vault of the Chapel of St. James (see Figs. 60, I, 33).

FIG. 59. VAULT OVER OLD BAPTISTERY

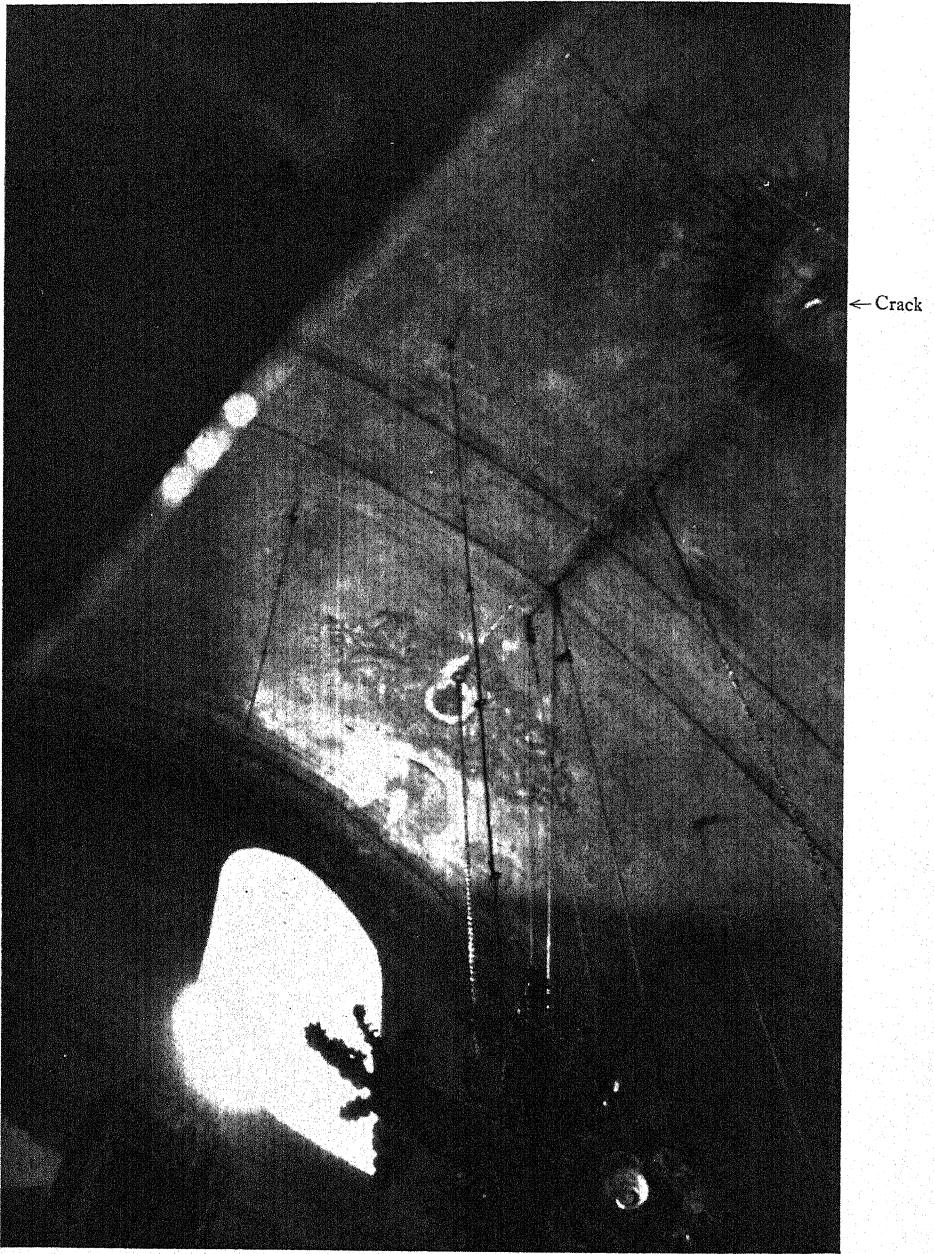
by $22\frac{1}{2}$ centimetres, and the crown of the vault is cracked throughout its length (see Figs. 63, V).

FIG. 63. VAULT OF CHAPEL OF ST. JAMES

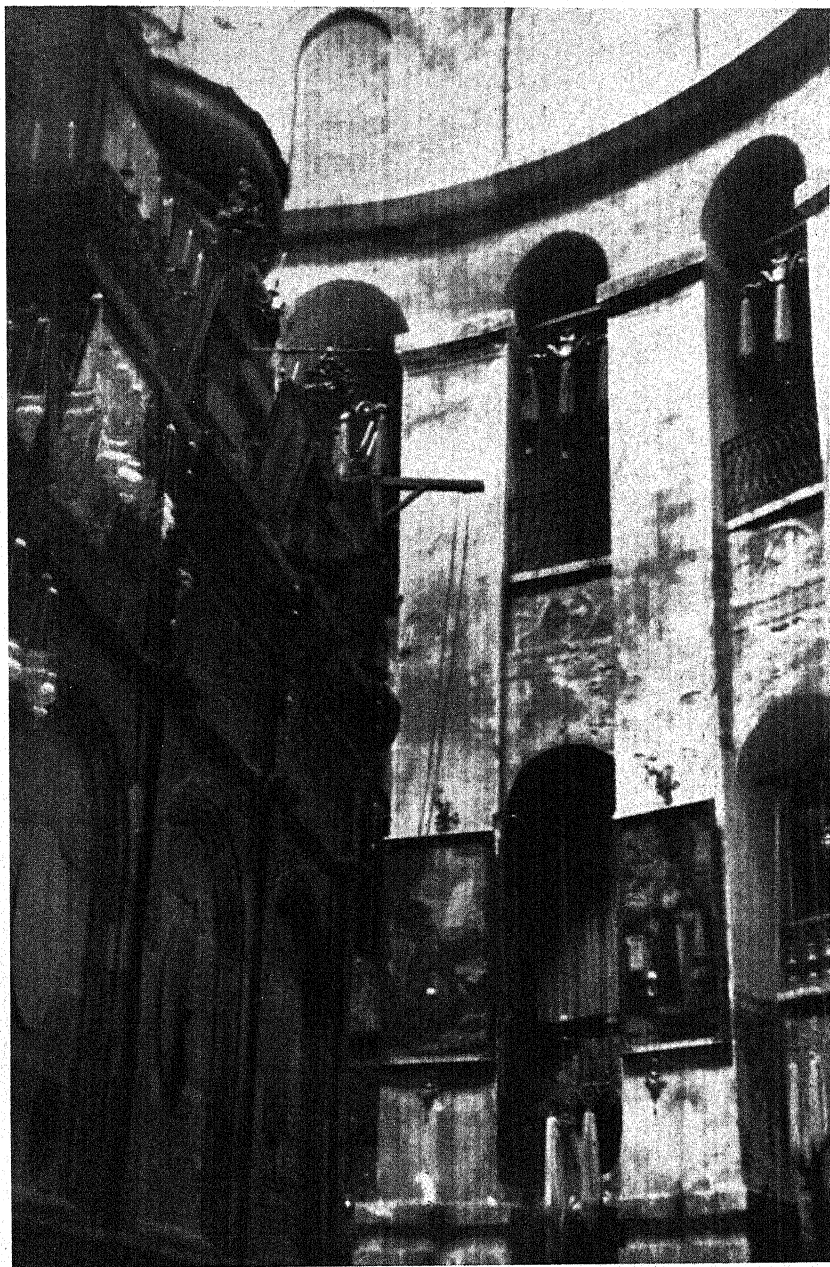
The piers of the main Rotunda (see Fig. I, 13) are now square (see Fig. 64), though they probably enclose as a core the earlier round columns of the building of Constantine Monomach (c. A.D. 1048). The present piers are clamped together with rusting iron (see Fig. 65), are very irregular in shape and size, and are not placed symmetrically beneath the circular drum built in 1867. They are therefore subject to eccentric loading, and all of them show cracks to a greater or less extent; some of these cracks are serious, though certainly due to earthquake shock as well as to thrusts (see Fig. 66).

FIG. 64. NORTH-WEST PART OF ROTUNDA

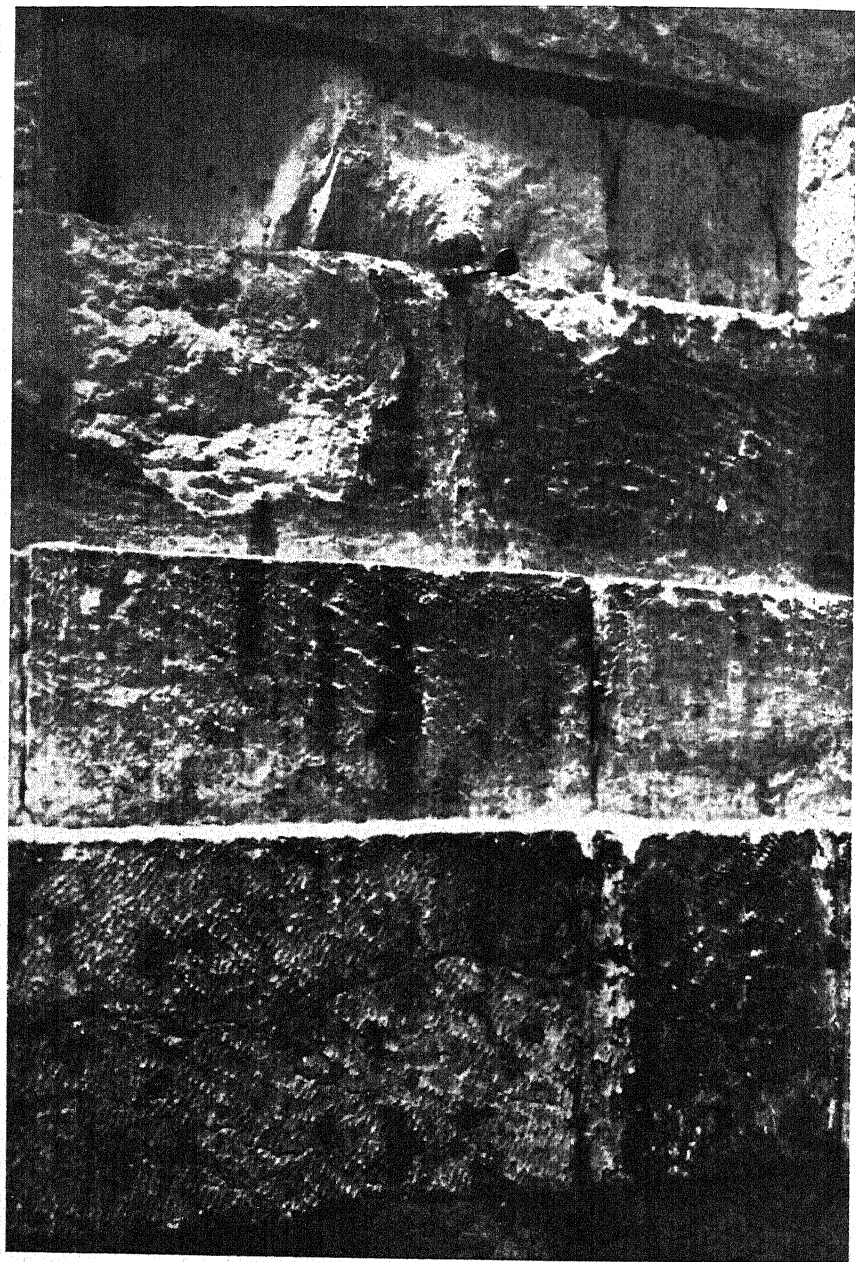
FIG. 65. FRACTURES DUE TO RUSTING IRON CRAMPS.
ROTUNDA PIERS

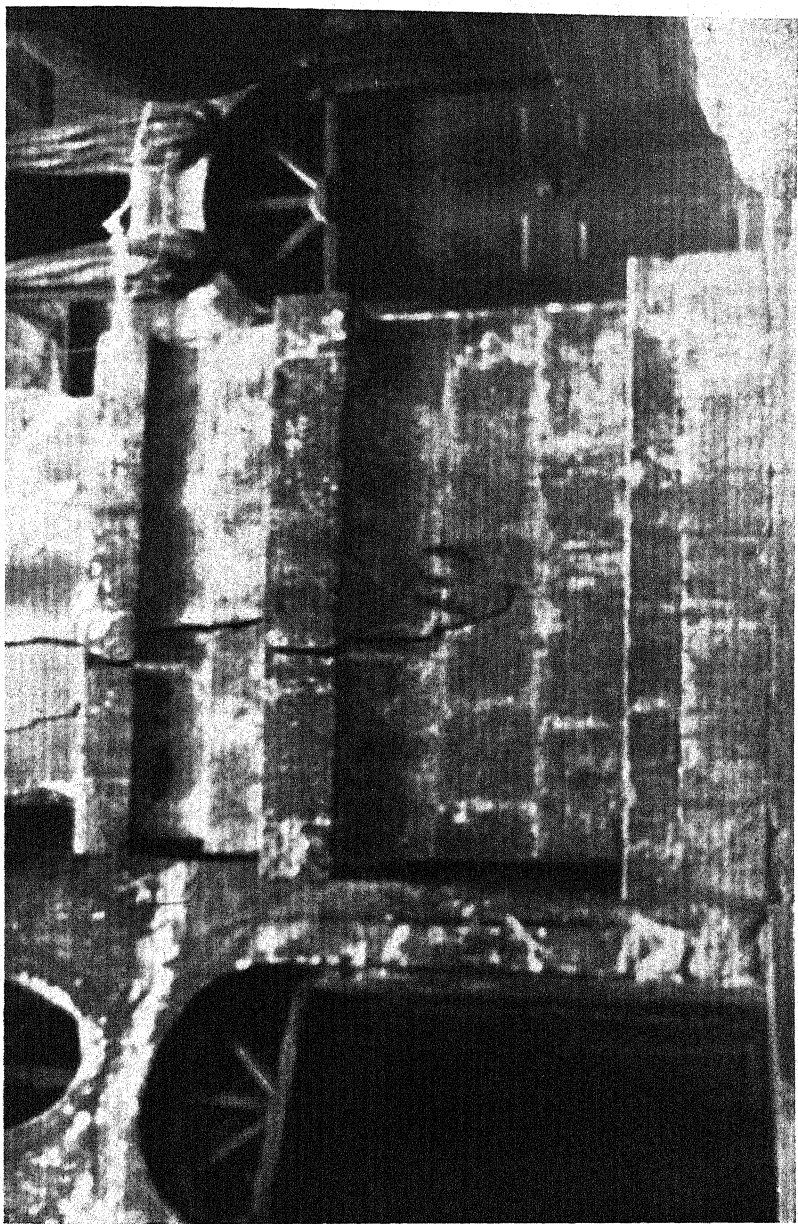
FIG. 66. FRACTURED PIER AT W. OF ROTUNDA

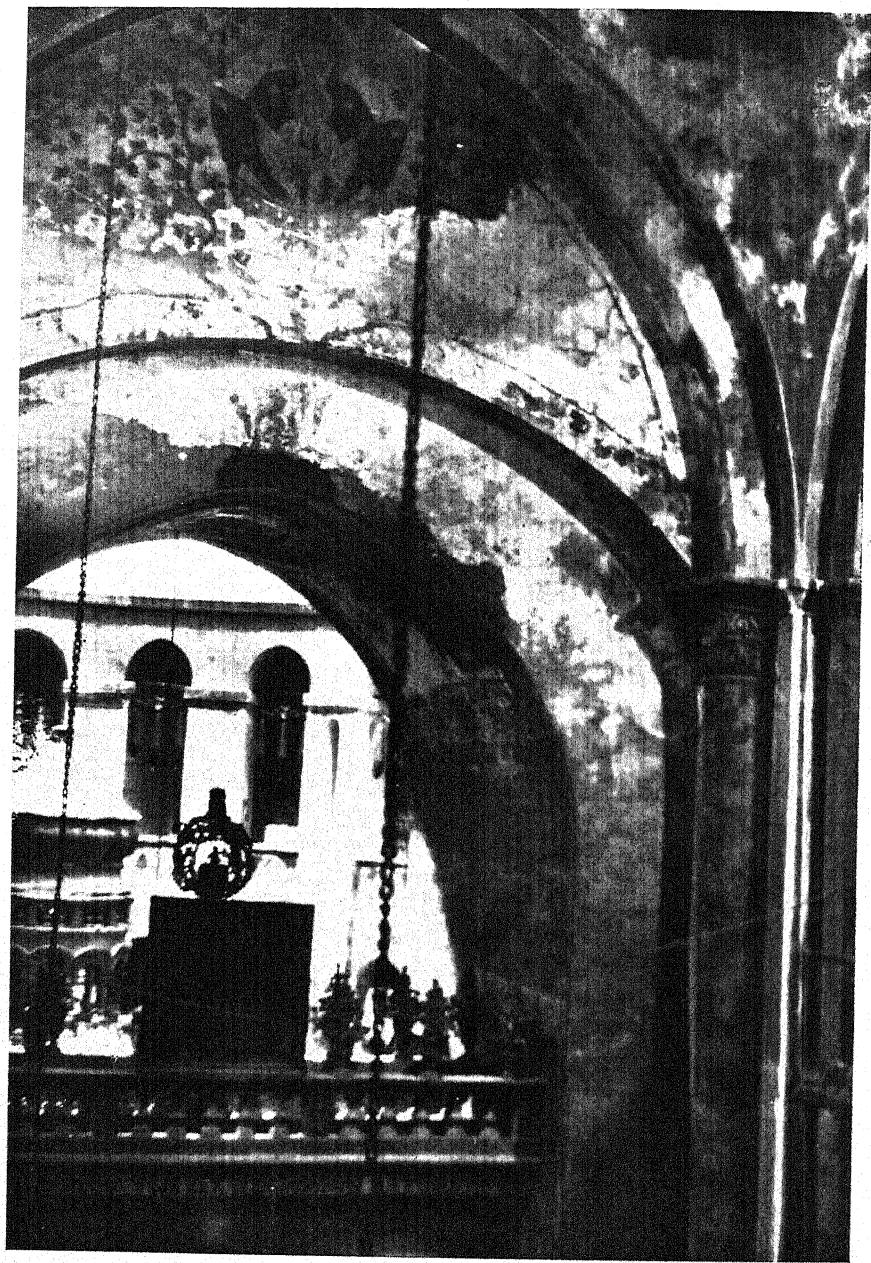
FIG. 74. GREAT ARCH OF ROTUNDA, SHOWING PLASTERING
OF 1810 CONCEALING CARVED WORK
